Restoration Specific Asbestos and Lead Based Paint Survey Report

**1206 Prairie Rd
Colorado Springs, CO 80909**

**Anderson Property Inspections
Colorado Springs, CO**

**Site Visit(s): 12/3/15
Report Date: 12/8/15**

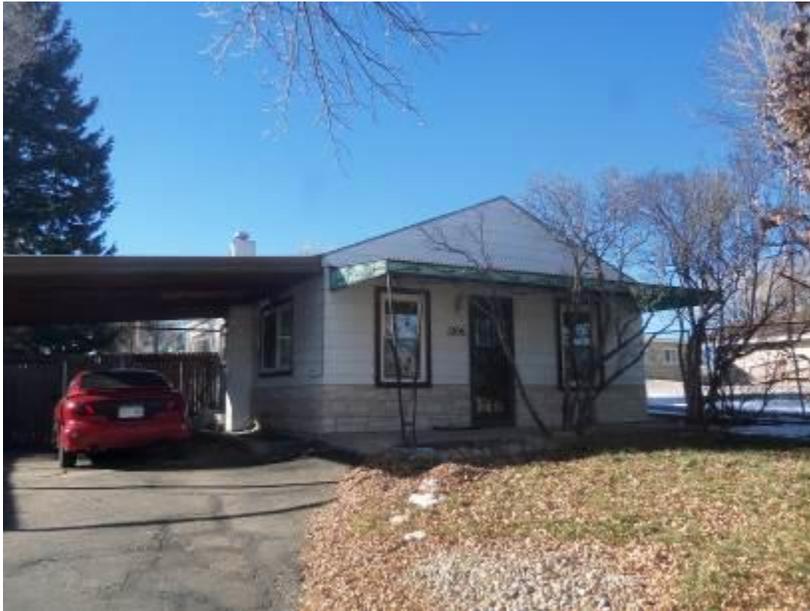
Front of dwelling note all door and window components tested negative for lead-based paint

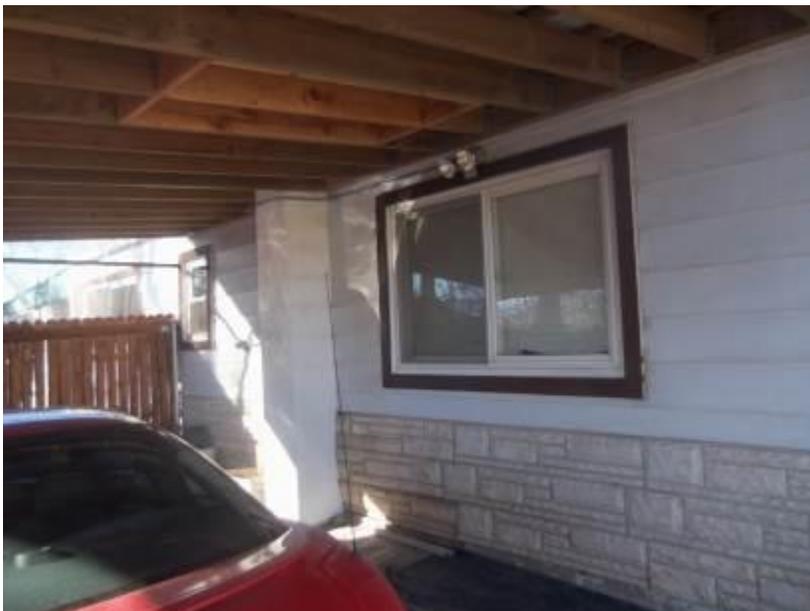
Close-up of window assemblies which appear to have been replaced in the last 20 years with vinyl all components tested negative for lead-based paint

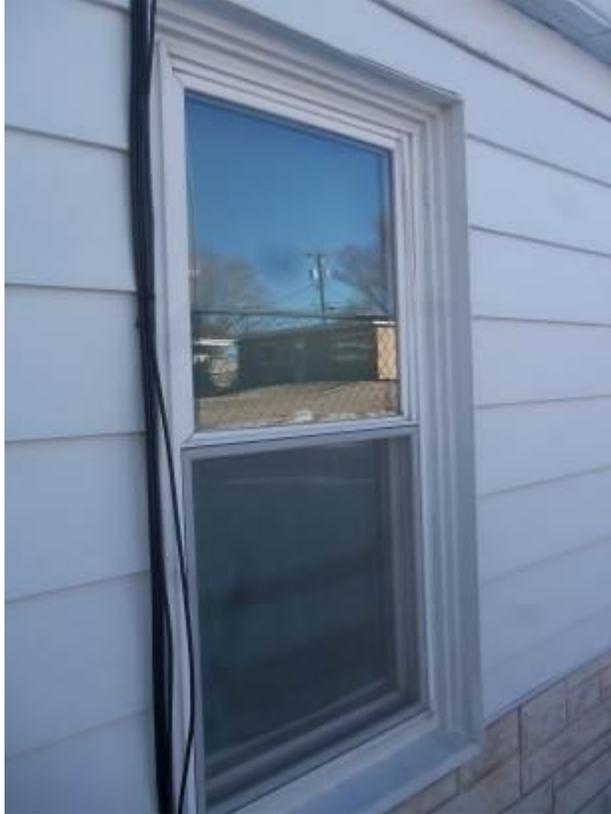
Some windows have no casement but sill and jambs tested negative for lead-based paint

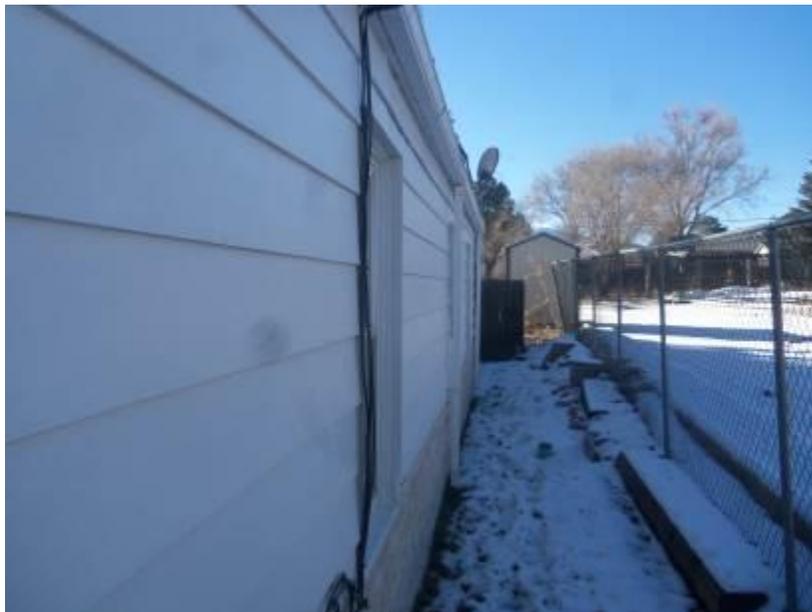
Northern elevation window components tested negative for lead-based paint

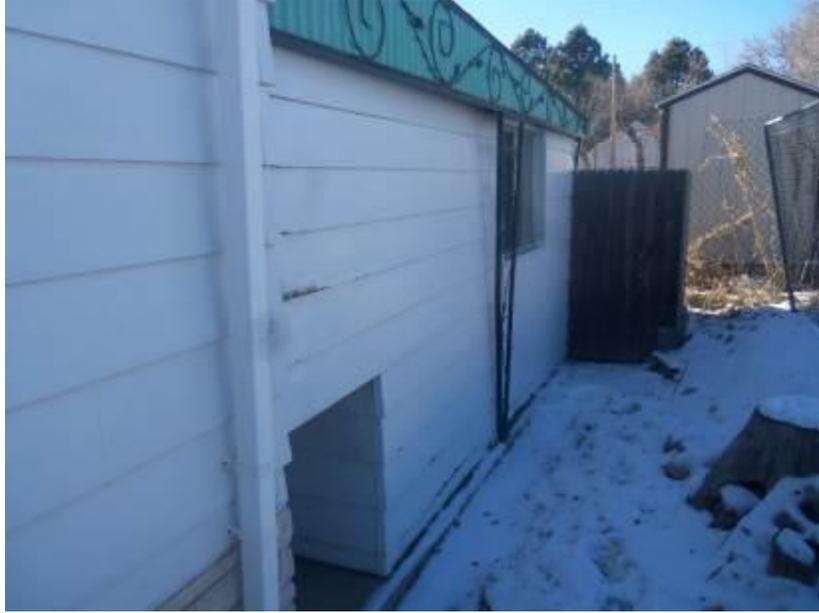
Northern and southern elevation have addition off west side newer material tested negative for lead-based paint

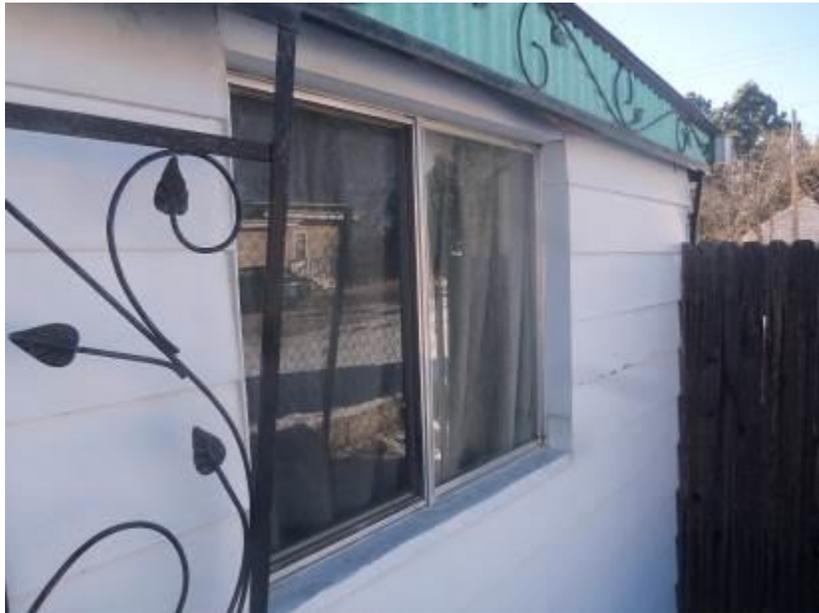
Metal framed windows on addition tested negative for lead-based paint

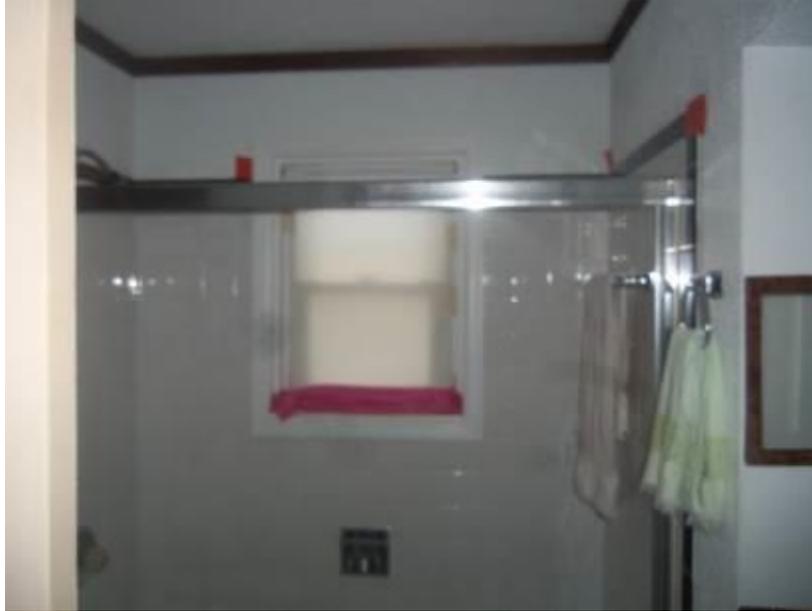
Overview of bathroom to be impacted note all materials slated for impact tested non-detect for asbestos and negative for lead-based paint

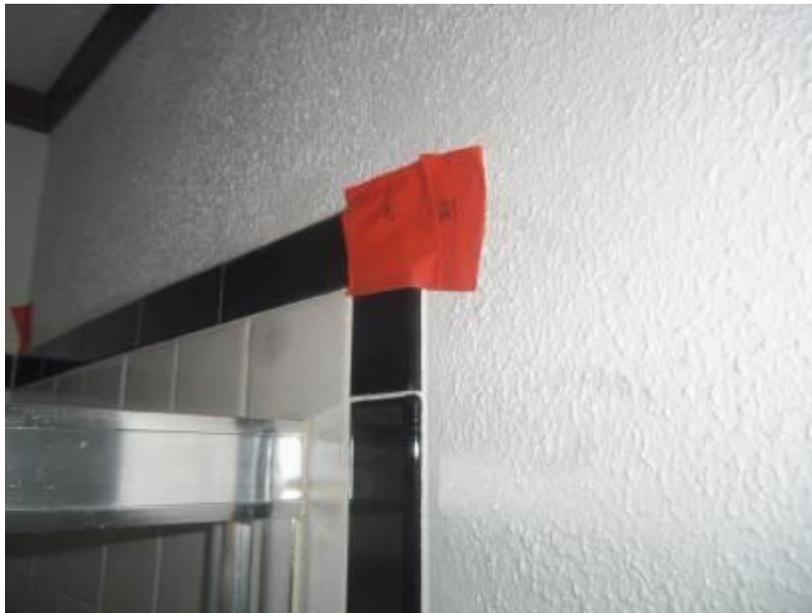
Tile surround and wall sample location both came back non-detect for asbestos

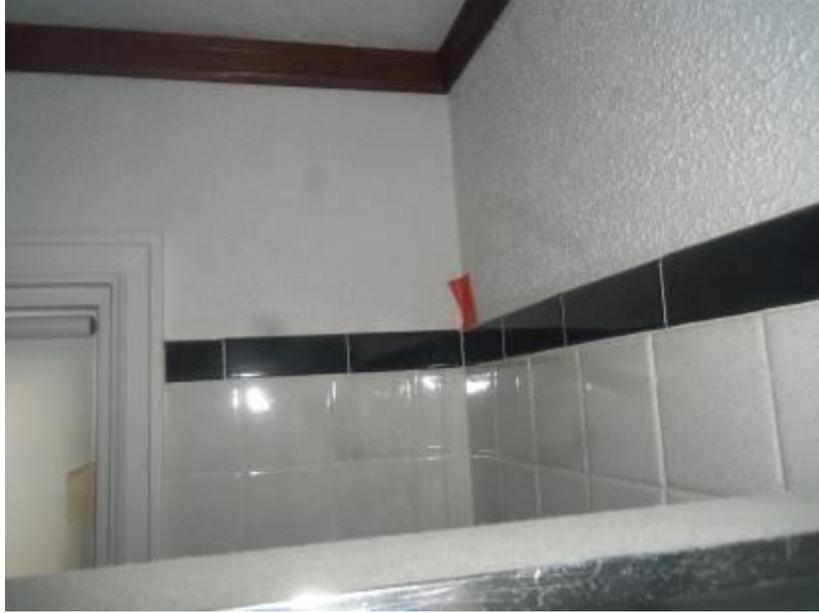
2nd sample of wall material in the bathroom is non-detect for asbestos

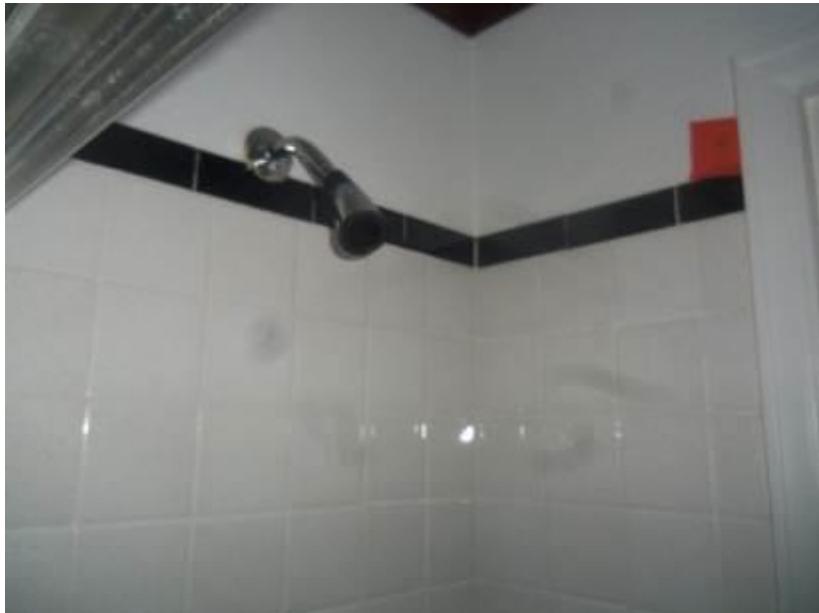
Sample 3 of wall material came back non-detect for asbestos

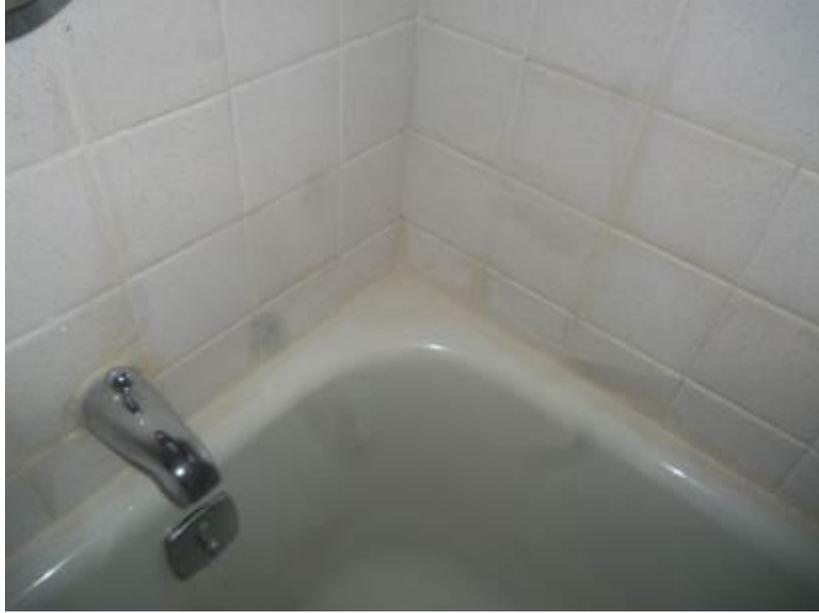
White sealant applied to tub surround is non-detect for asbestos
